Project:
Bethesda Christian Church

Manufacturer:
IB Roof Systems

System:
Fully Adhered
80 Mil Membrane

Project Profiles

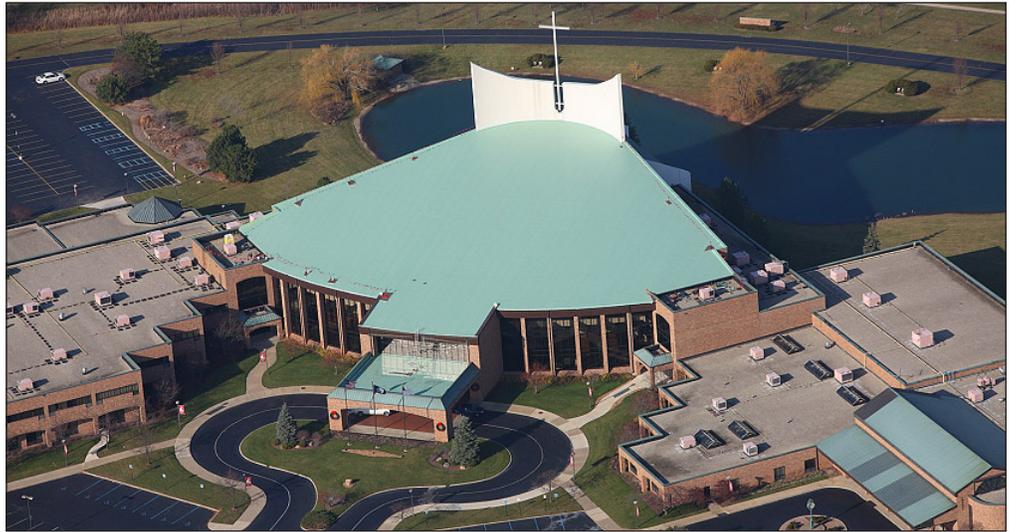
BETHESDA CHRISTIAN CHURCH

feet from wall to gutter. Bethesda chose Mike's bid using IB Roof Systems' 80 mil PVC membranes to replace the copper roof. Still, the congregation wanted to maintain the same look and feel, so the membranes were special-ordered to be the same copper color. The appearance so closely replicated the original copper that churchgoers were surprised to learn that it wasn't real copper.

The church has a pitched roof, with a rising incline of 14 feet. As a result, the roofers were forced to roll the membranes uphill. Each piece of PVC was rendered individually so there would be no seams.

Sharpe Inc. installed Bethesda’s new roof using IB’s 80 mil PVC membrane, fully adhered with IB’s water based adhesive, and replaced all the church’s copper copings with 16-ounce copper, each piece manufactured specifically for the project. All of the flashings were installed seamlessly.

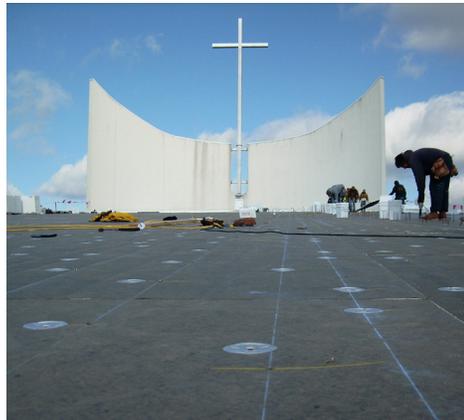
“We chose to put down a protective canopy shield over the roof to keep the rain out,” Mike explains. “It cost nearly \$30,000 to cover it, but it was worth the extra money because it rained the second day on the job.” With the canopy in place, not a single drop of rain got inside the church. “No other contractor thought of it,” Mike says.

After removing the copper roof, Sharpe Inc. added a second layer of 2-inch ISO insulation over the existing plywood. Next they installed 3-inch plates using heavy-duty screws to fasten the insulation. Sharpe Inc. used the FM I-90 pattern for uplift, one fastener per 2 square feet over the entire roof.
