Project:
Pleasant Hill Schools

Manufacturer:
IB Roof Systems

System:
Mechanically attached using standard white colored membrane

PLEASANT HILL SCHOOLS

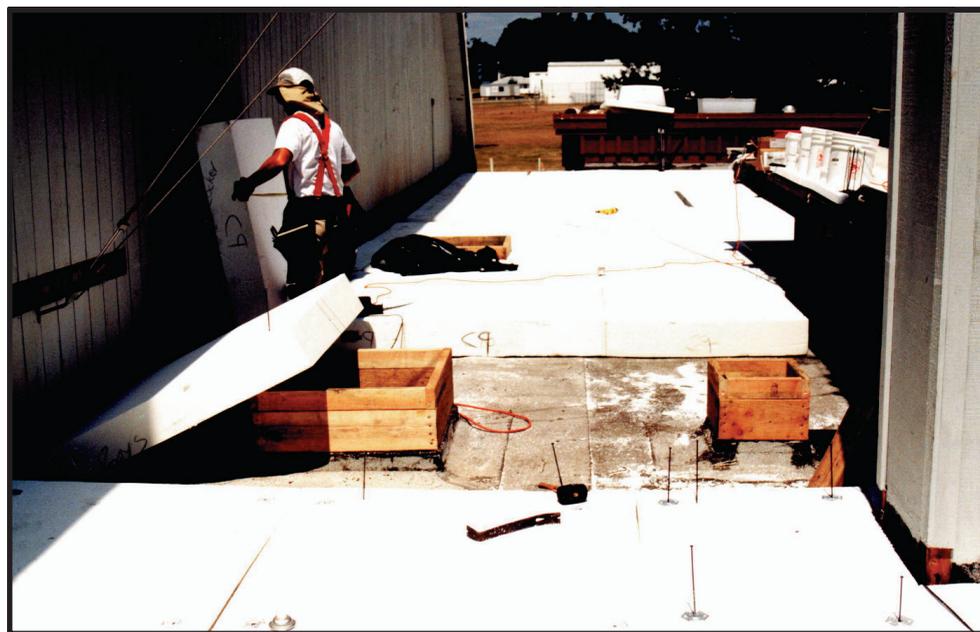
Tapered foam system installed to fill & slope low areas

Bob Loboto wanted Pleasant Hill schools to accomplish the same. A roof specification was written calling for IB single-ply membrane and the job was awarded to A-1 Roofing of Eugene, Oregon. Soon the two sides were teaming up to develop a cost-effective, lightweight tapered foam system. It was

created from durable 1.5 lb density EPS foam insulation to direct the water where it needed to be. Next, the reinforced CPA membrane was applied to the roof. Every seam was hot air welded and the roofs were encased under a one-piece blanket.
